Super Salvage, Inc.
Industrial Stormwater Inspection Report

Appendix B

Photograph Log and Photographs

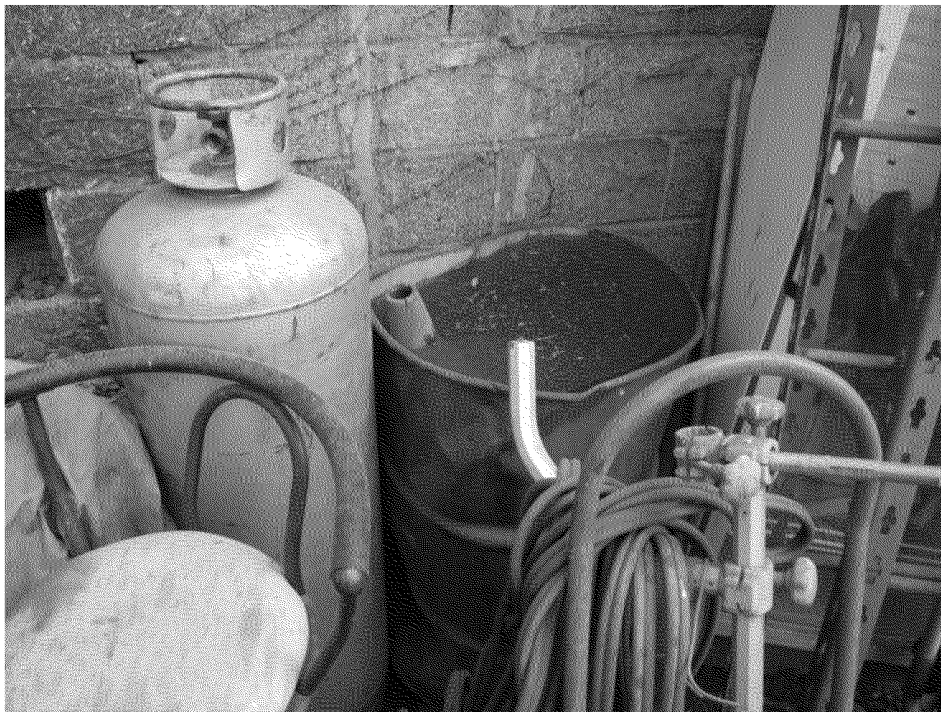
Photograph 44. Close-up view of a drum adjacent to the northern end of the large runoff collection pond. Note the drum is uncovered and containing a gray fluid.

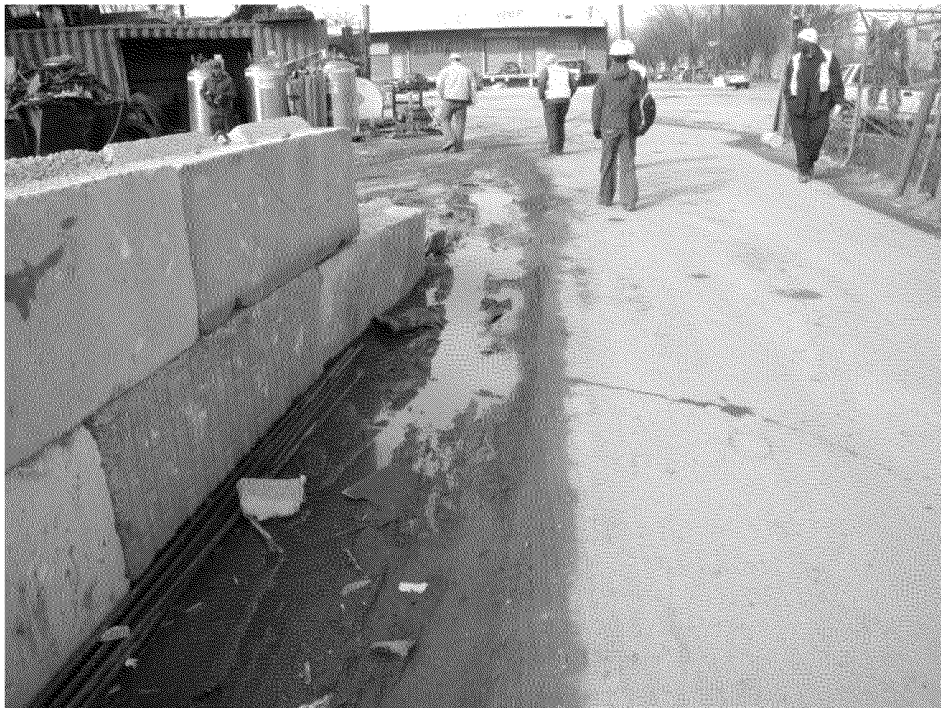
Photograph 52. **Left side of the car path looking north towards Entrance 2.**

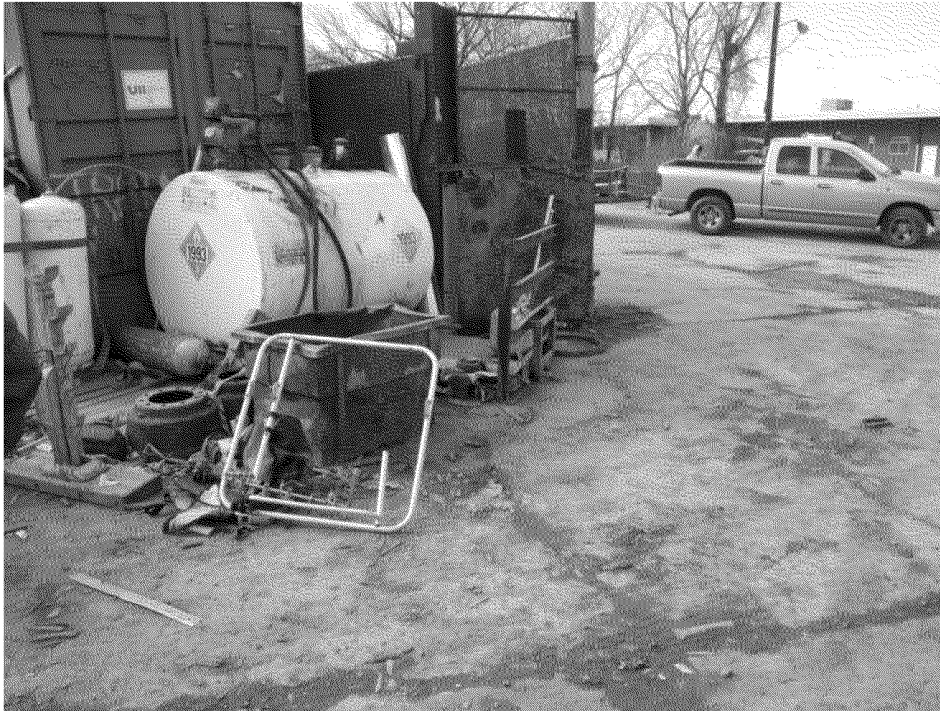
Photograph 53. 500-gallon diesel tank stored by oxygen tanks near Entrance 2.

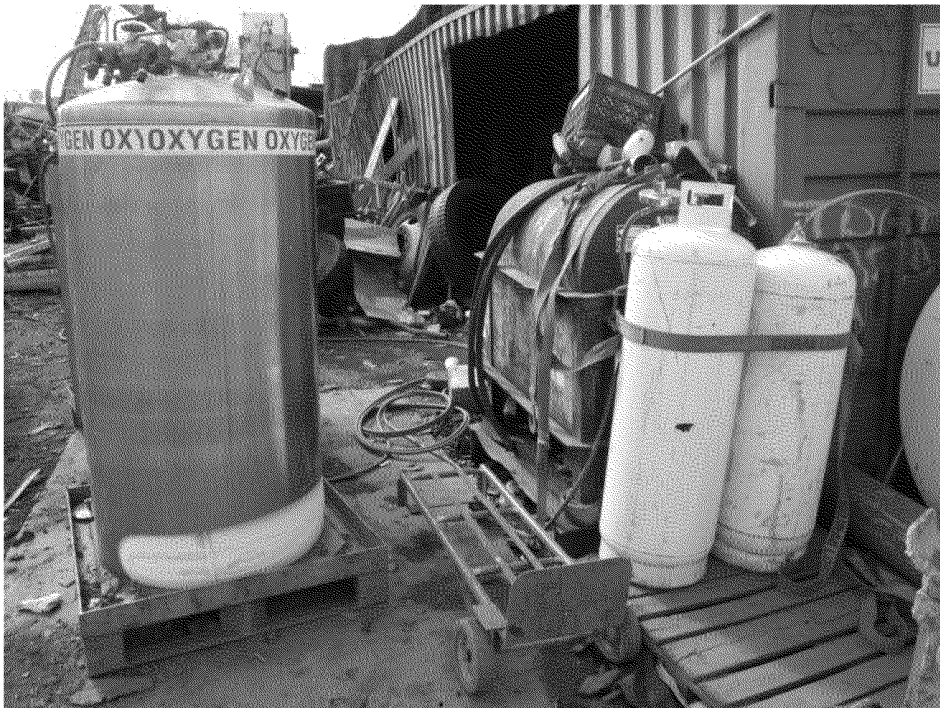
Photograph 54. Compressed gases stored near oxygen tank and fuel used for torches.

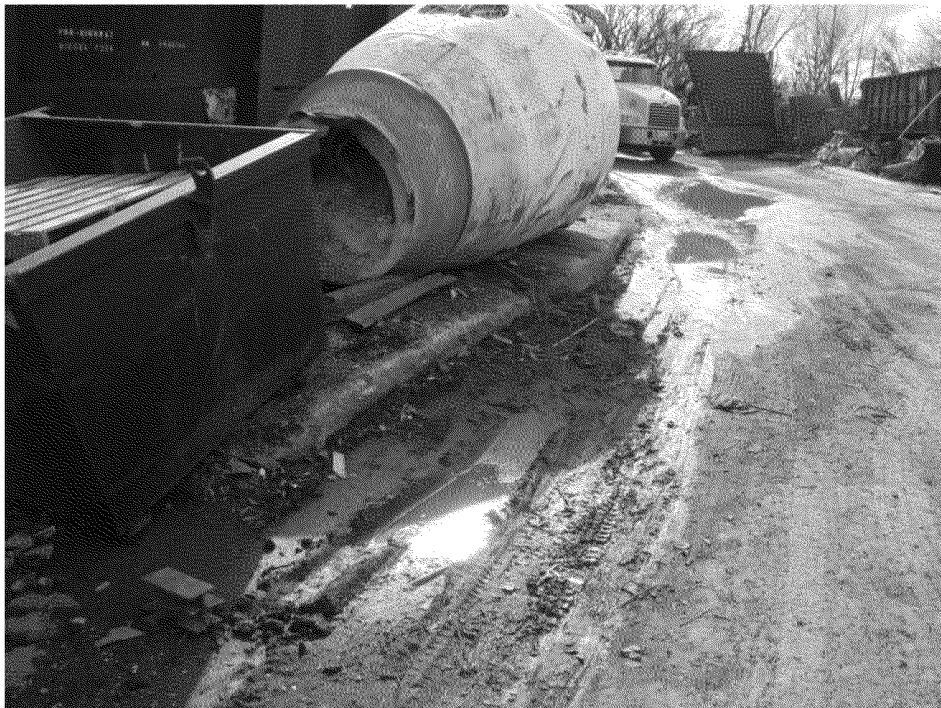
Photograph 58. Storage of debris outside the perimeter of the facility adjacent to the DC property .

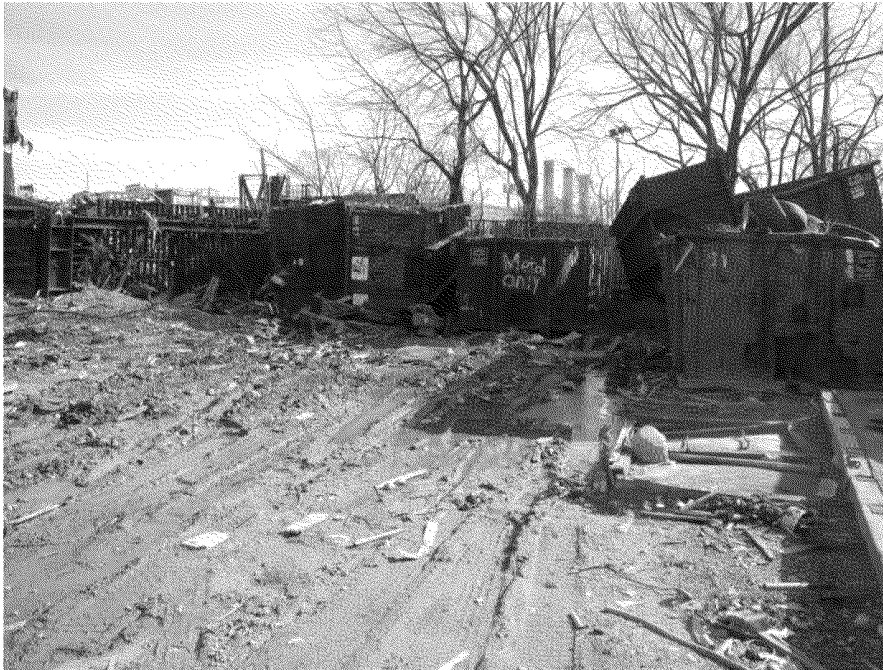
Photograph 63. Super Salvage dumpsters containing scrap stored on DC property near the Super Salvage property line. Note liquid draining from the dumpsters.

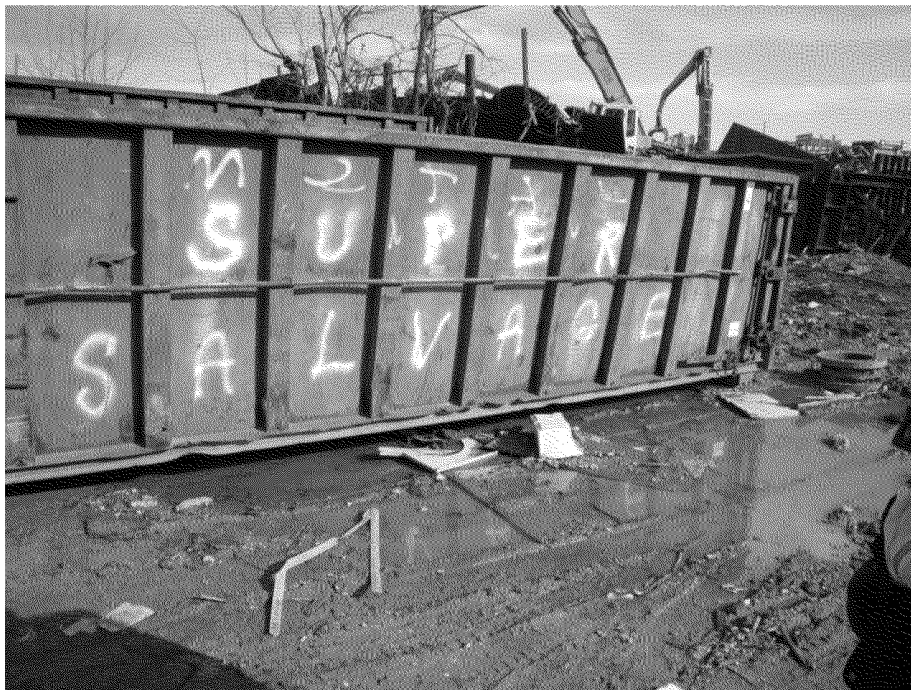
Photograph 64. Super Salvage metal dumpsters and pooled water. Dumpsters are located on DC property adjacent to the Super Salvage fence line.

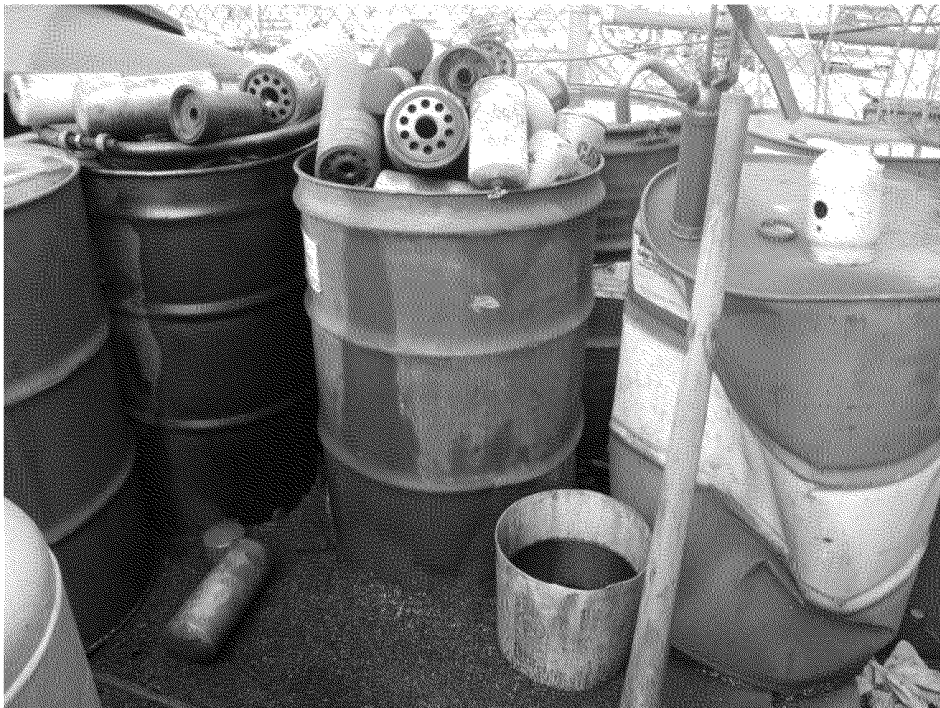
Photograph 70. **View of open buckets and storage drums containing used oil filters on top of secondary containment covered in absorbent material.**

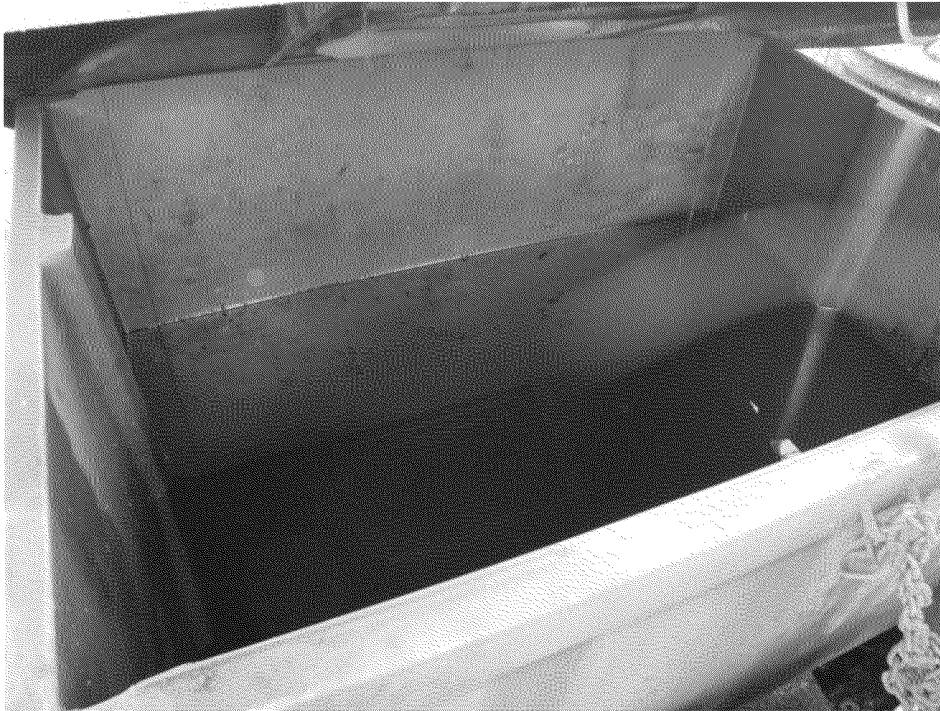
Photograph 71. Plastic container/dumpster of what appears to be waste oil adjacent to the property boundary.

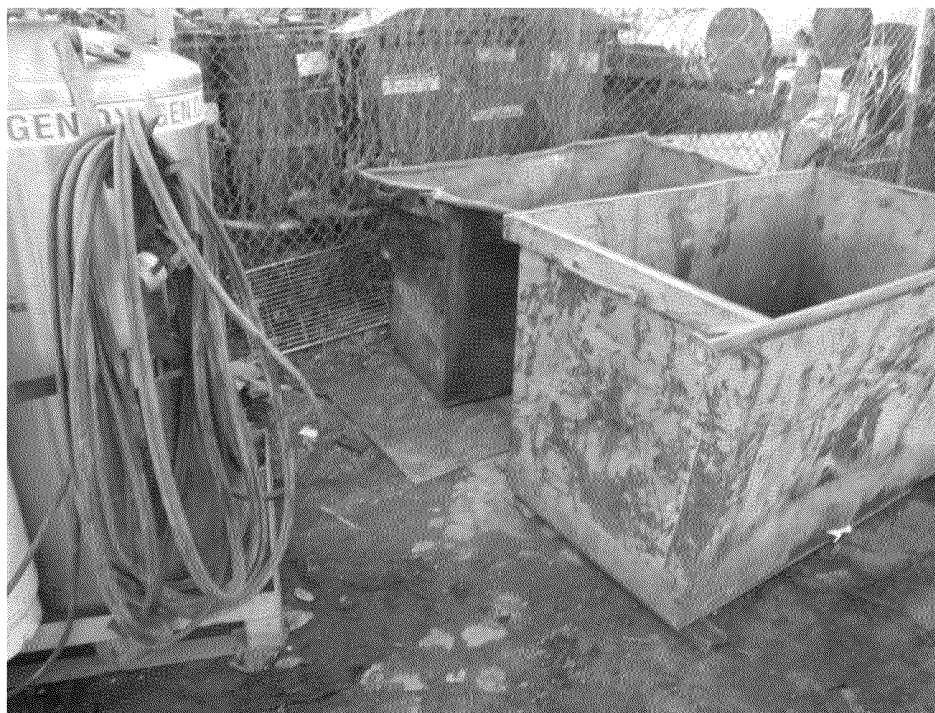
Photograph 77. **Alternate view of items stored outside of the perimeter fence.**

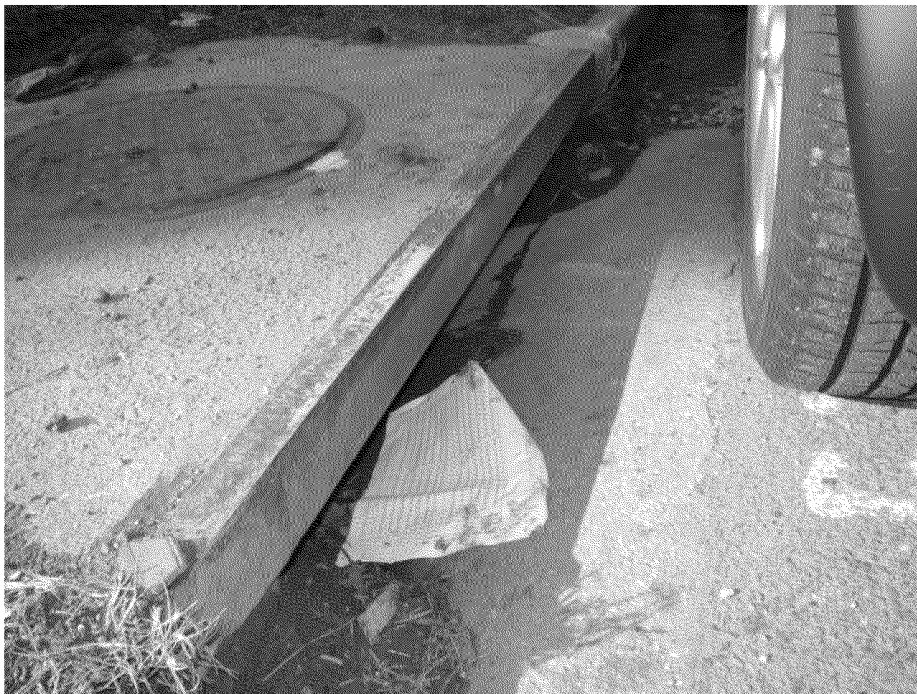
Photograph 80. View of storm drain closest to site near the corner of First Street SW
and S Street SW.

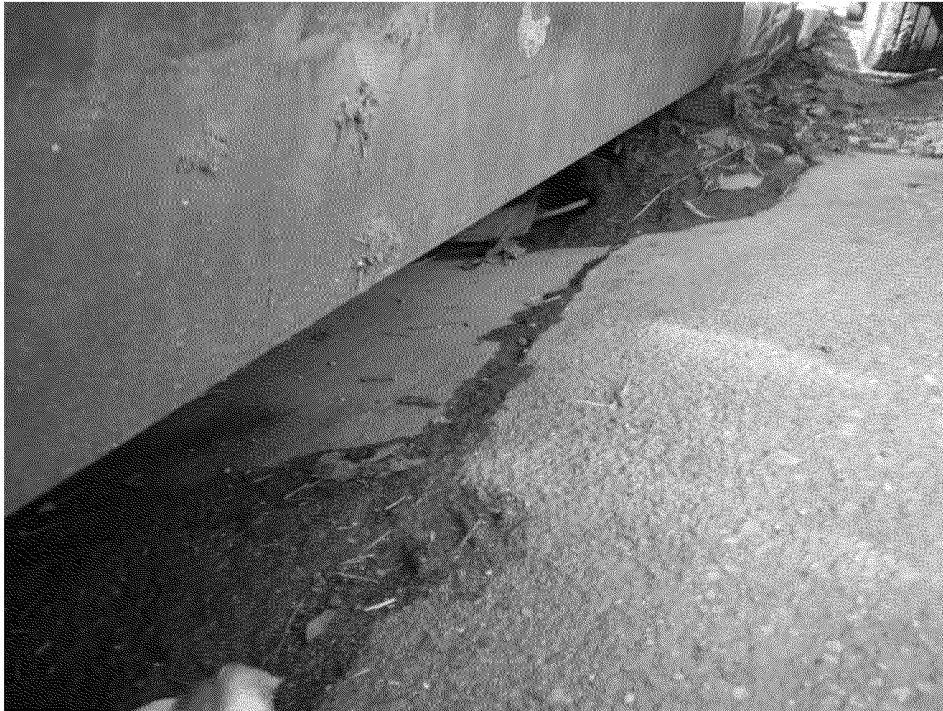
Photograph 81. Close-up view of the storm drain with sediment entering from street.
Storm drain is near the corner of First Street SW and S Street SW.
